MAKING THE GRADE

Dredging, regrading a Florida pond restores functionality, enhances maintenance

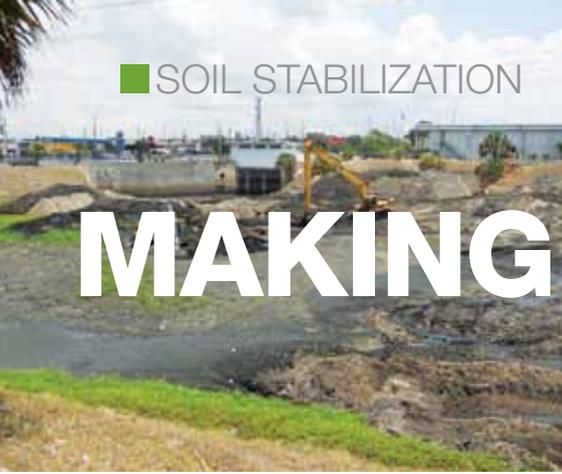
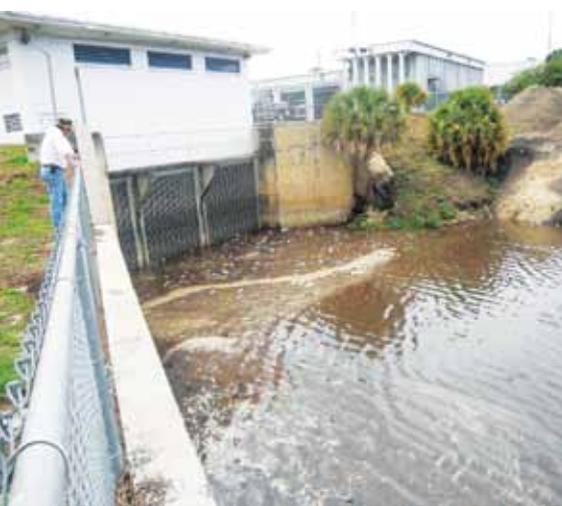
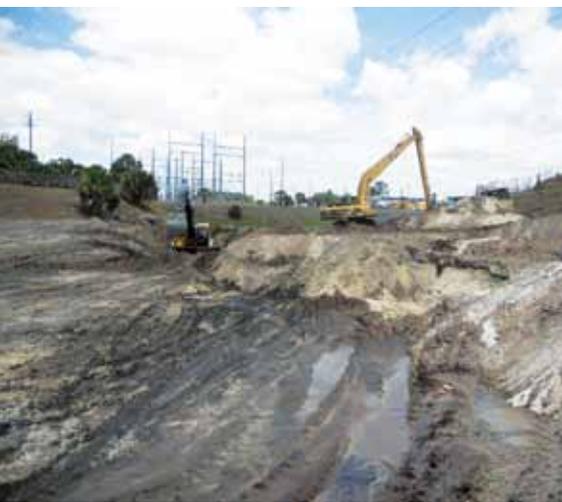
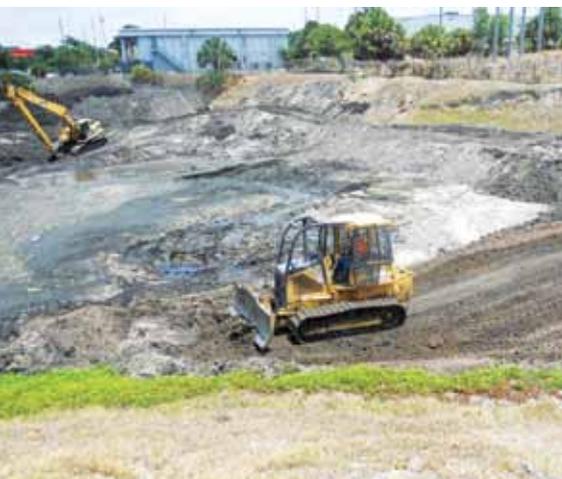
In 2011 and 2012, because of low rainfall, more pronounced areas of slope failures and larger volumes of sediment were noticeable. To remedy the failing slopes, they explored the possibility of installing cable concrete, but it was not recommended for such steep slopes. In addition, mowing and spraying operations became difficult due to access, depth and steepness of side slopes.

Because the accumulated sediment and debris also had reduced the storage capacity of the pond, staff decided to remove the sediment from the bottom of the pond and regrade, bench and re-sod

the slope to break the adverse slope. Due to the high cost of outsourcing this work inclusive of dredging, retrofit of the pond was performed by the in-house heavy equipment crew. Dredging activity would increase the capacity of the pond and the reshaping of the pond would aid maintenance once the adverse slope was corrected.

to nine staff members. The crew utilized a variety of equipment, including long and short boom excavators, a backhoe, dump trucks, 6-in. pumps, pickup trucks and flat beds. The primary scope of the project included removing two 5-ft areas of sediment from the bottom of the pond, regrading the slope from a 2:1 to 3:1 gradient, and building a maintenance berm across the central access berm along deeper sections of the pond and around the perimeter for ease of access and future maintenance. This work was performed with minimal impact to surrounding commercial and residential neighborhoods. Several outfall structures within the pond had to be modified to match new bottom elevation and reduce erosion due to splashing. Splash pads and rock rubble were used to address the erosion control at mitered end sections of the outfall pipe.

The Woodsmere Pond project was completed in November 2013, integrating varying slopes that would allow easy access to equipment and be less likely to fail; it also now is an aesthetically pleasing pond with higher capacity. From the inception of the project to final completion, it took 60 days at a cost of \$170,000. **SWS**
