PICKING UP THE PIECES

Landslide disables Idaho mountain town corridor

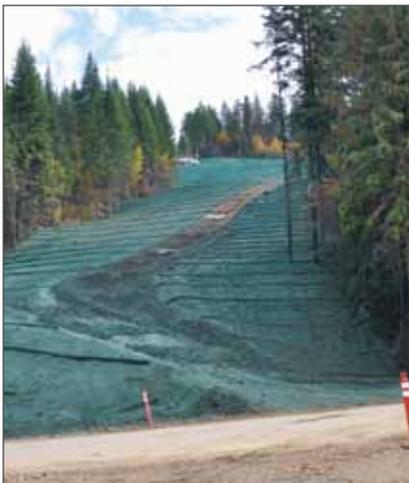
The treatment of the slope was completed just before the end of fall 2013.

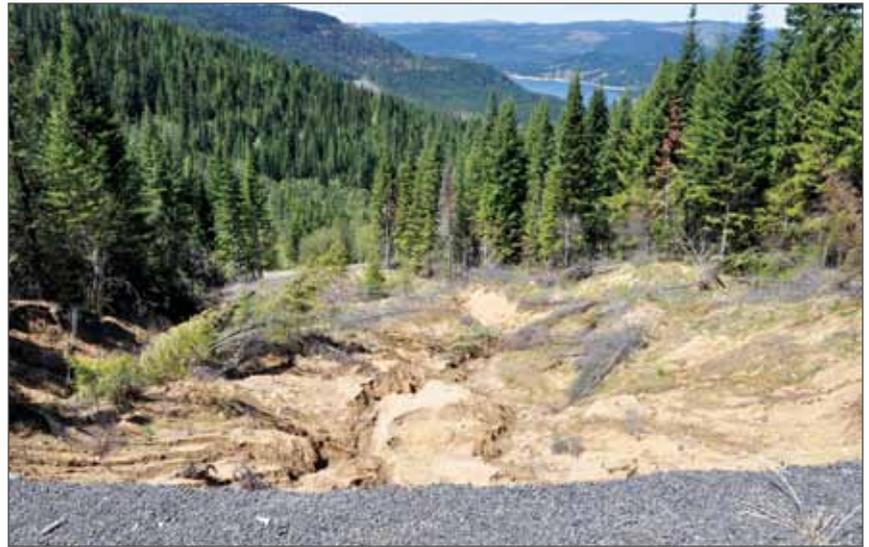
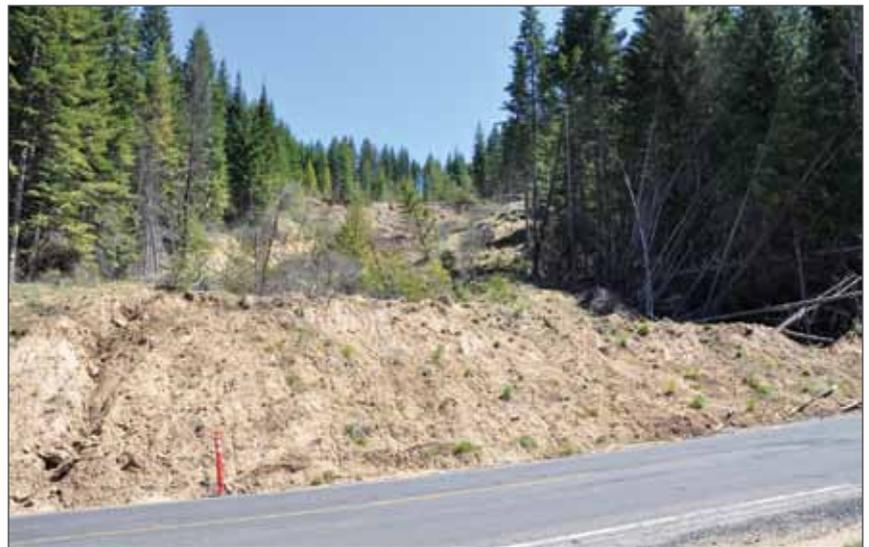
A massive landslide occurred as a result of intense runoff, causing significant damage to the road infrastructure and surrounding slopes.
