Turn of the Tide

Coir logs repair an upland dike damaged during Superstorm Sandy

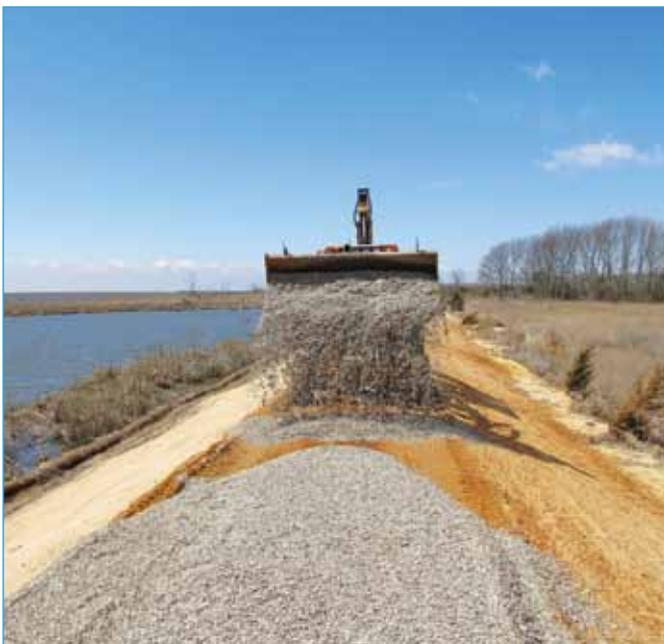
A road made of crushed seashells is laid.

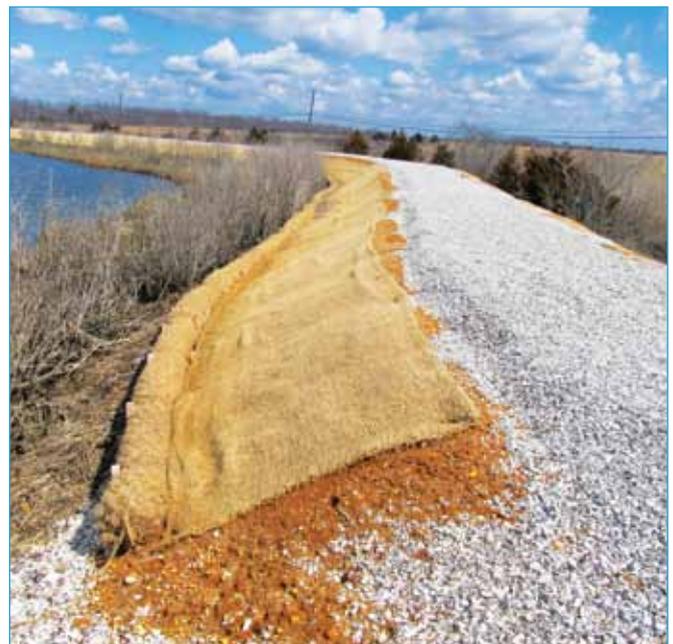
The coir log installation

Following consultation with Pinelands Nursery, the EEP decided to use a combination of East Coast Erosion Blankets coir logs and coir mats. In total, more than 3,400 ln ft of coir logs were aggressively staked into the dike's bay-facing side, toed in just above the mean higher high water elevation. The logs are ideal mediums for bank restorations because of their durability, strength and ability for plant colonization. Standard-grade logs are typically 12 ft long with a 12-in. diameter and weigh about 60 lb. Soil was back filled against the base of the logs up to the crest of the dike, then tamped into place. To stabilize the project, more than 29,500 sq ft of 900 gram-per-sq-meter coir mats were pinned down over the fill from the crest of the dike to the top of the coir logs. Traditionally, these mats would be planted with native species, but the EEP chose to evaluate the vegetative regrowth for at least one growing season. In the event the mats do not naturally vegetate, plantings may be performed

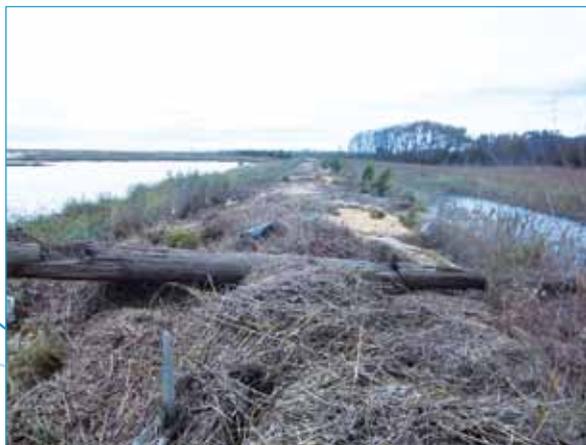
Almost 3,500 ft of the upland dike system in Port Norris, N.J., were severely damaged during Superstorm Sandy.

Reconstruction of the damaged dikes began in late November 2012 and was completed in early April 2013. To minimize wetland impacts, the dike repairs were made from the dike crest and within the original footprint. Because the storm tides relocated much of the original dike material, approximately 4,600 cu yd of suitable structural fill were hauled to the site. The dikes were rebuilt to the design elevation, followed by the reconstruction of appropriate side slopes. Where portions of the crest of the upland dikes are frequently used by visitors, more than 20 loads of shell were placed for continued use as a nature trail. To minimize the risk of future erosion, the EEP investigated numerous options to stabilize the side slopes and protect them from the adverse effects of future storms.

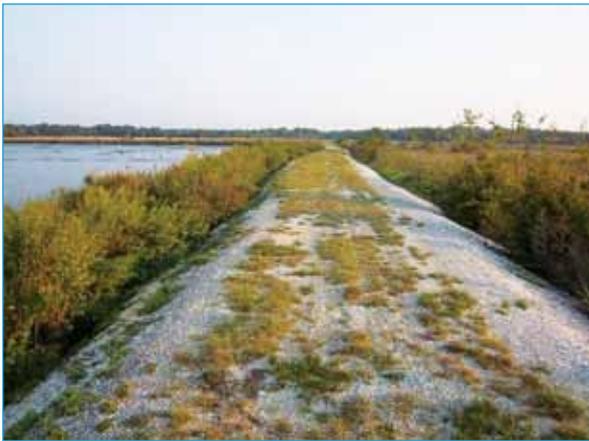
The dikes now are fully repaired with the coir products installed.

at a later date where appropriate. The revegetation of these mats has started to take place as many *Iva frutescens* (high tide bush) and *Baccharis halimifolia* (groundsel tree) seedlings have started to grow through. It is anticipated that the dike will be completely vegetated in two to three years.
