RENEW & RESTORE

Restoration of a beachside canyon & channel

By John McCarthy & Richard Beck

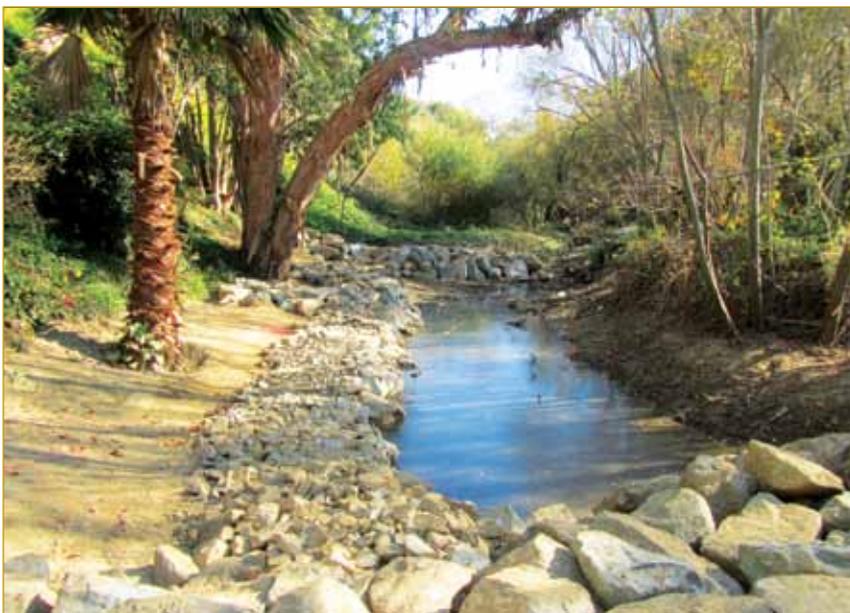
Buck Gully Channel runs in a southwest direction in a natural drainage system with a total tributary area of 1,070 acres at its ocean outlet, of which 637 acres are urbanized within the watershed.

Buck Gully Channel runs through the study reach in a southwest direction, in a natural drainage system with a total tributary area of 1,070 acres at its ocean outlet, of which 637 acres are urbanized within the watershed. Hydrologic and hydraulic analysis of the Buck Gully watershed and channel within the

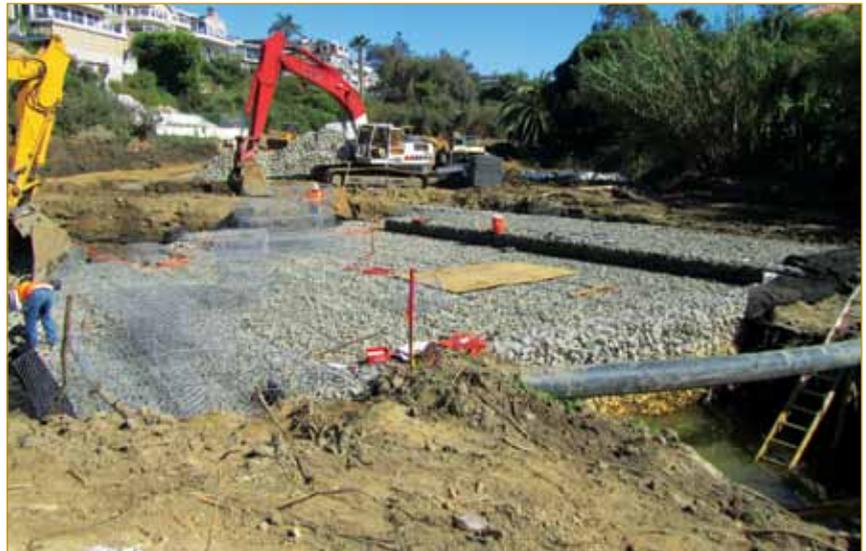
A channel stability analysis was prepared based on the results of the hydrology and hydraulic calculations to assess the long-term trends of Buck Gully Channel.

long-term trends of Buck Gully Channel through the study site. This analysis reviewed sediment continuity, equilibrium slopes, armoring potential, wash load, and vertical and horizontal channel response.

The sediment transport analysis identified recommendations, including the use of three gabion drop structures to obtain stable channel slopes based on the new watershed conditions. Rock-filled gabion mattresses were recommended for the drop structures in the channel. These environmentally preferred structures were installed with minimum construction impact using small equipment. The structures were backfilled with soil and vegetated to blend with the natural channel environment. Native willow cuttings also were installed at bankfull and around the gabions for additional bank support.

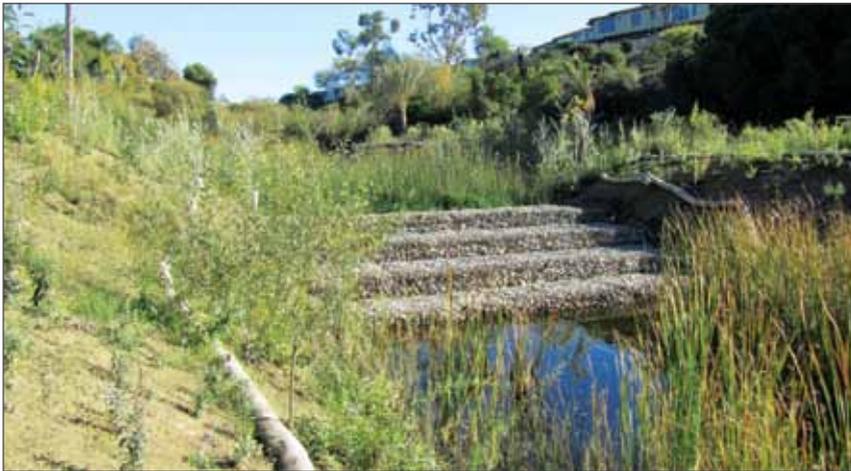
Early water quality monitoring results show an 80% decrease in fecal coliform and other lower constituent levels once water filters through the project site.

Early water quality monitoring results show an 80% decrease in fecal coliform

and other lower constituent levels once water filters through the project site. The California Coastal Commission staff has called this “a model restoration project” as the year one monitoring results found significant native vegetation cover and more diverse species, well beyond permit requirements. The stability of the channel has allowed for a variety of species to take hold, ranging from early grass species for erosion control to understory/streamside species and tree species like willow, sycamore and cottonwood. The project will continue formal biological monitoring in the spring and summer of 2014. **SWS**
