Vegetation for Stabilization

Canal restoration project leaders choose an erosion control system that looks natural, protects a Florida ecosystem

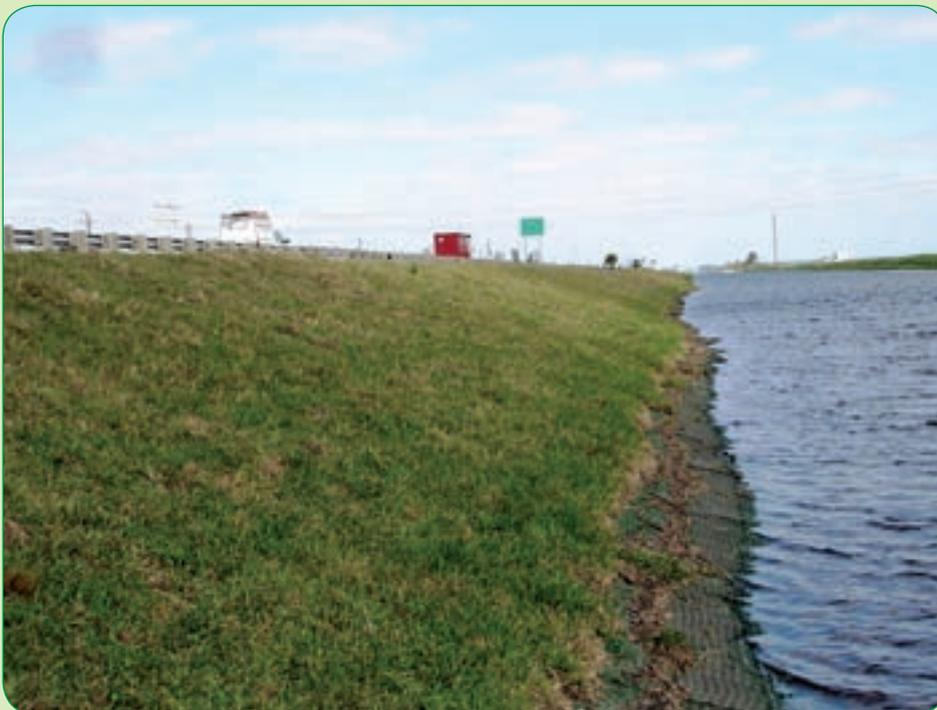
The SFWMD achieved a natural post-construction look on canal C-51.

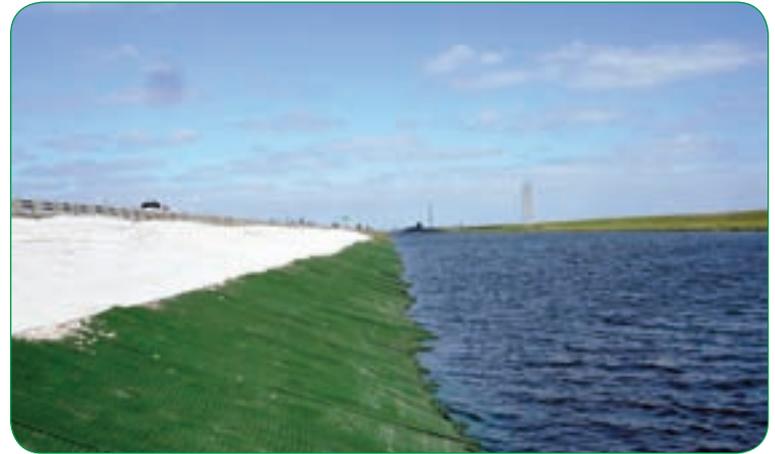
Workers installed approximately 55,000 sq yd of TRMs in about 60 days.

The portion of C-51 that utilized the woven TRM measures approximately 55,000 sq yd. An additional 4,000 ft of shoreline is protected with articulated concrete block. NEC crews, made up of three to five people depending on the area of the slope being covered, installed the Landlok 300 with a No. 4 stone at the bottom of the canal. The initial goal was to have the TRM installation completed in 90 days, but the work was done in about 60 days.
