[EROSION PREVENTION]

Damage Control

Site stakeholders collaborate to protect downstream resources

The City Center North Village is a 68-acre multi-use development in Lenexa, Kan. It will combine high-density commercial and residential development, storm water best management practices (BMPs) and pedestrian-friendly design to create a “new urbanism” community.

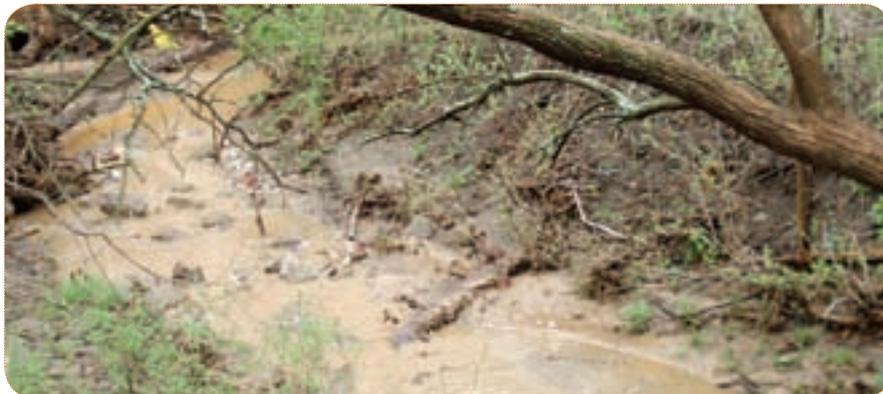
Lenexa received approximately 3 in. of rainfall on March 29, 2007. The next morning, the water quality specialist and erosion and sediment control inspector conducted site inspections throughout the city to determine the extent of runoff and sedimentation. Perimeter BMPs had failed at City Center North Village, and a significant amount of sediment had left the site

and impacted the eastern cove of Shawnee Mission Lake.

Runoff from the western portion of the site blew out a perimeter mulch berm and rock check, with a sediment plume visibly leaving City Center North Village. Runoff from the central drainage had eroded underneath and around three ditch checks, and sediment-laden water was visibly leaving the site.

Rainfall sent sediment-laden site runoff into Shawnee Mission Lake via an unnamed tributary.

Within 24 hours, the contractor was required to complete the following: repair existing rock checks and face them with gravel; maintain perimeter mulch berms and replace those along the western drainage; and place an additional rock check in the western drainage. Within 10 working days, the contractor was required to install sediment basins with skimmers and maintain and replace all other onsite sediment controls as appropriate.

All existing rock checks were originally constructed with large rock (12 in. or more) excavated from the site. The contractor was instructed to use smaller rock faced with 0.75-in. clean gravel. After making repairs and installing additional rock checks, water began to pond, increasing settling time and filtration.

The existing sediment pond was cleaned out to provide more settling time, but there was not a good way to mix flocculants into the pond. The contractor installed bags of BioStar CH (natural chitosan) in the outfall pipe, increasing settling throughout the receiving stream and rock check system. No water quality samples were taken during this project. Water clarity, however, did appear to improve after flocculants were added to the system of controls.

The main sediment ponds were eventually installed, but shallow bedrock and slow sewer line removal activities hindered progress. All ponds were equipped with skimmers to enhance sediment removal. As mass grading proceeded, the series of rock checks and sediment ponds sufficiently controlled runoff and protected downstream resources. **SWS**
