# Mount Ruthless

As a Connecticut mountain highway undergoes extensive reconstruction, project leaders take water quality precautions

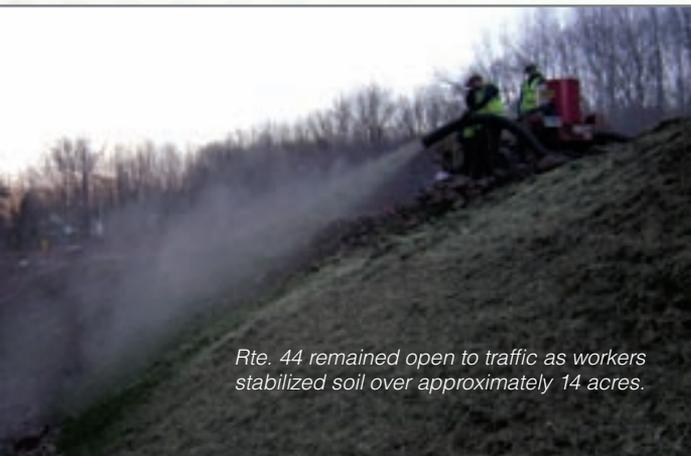
*Rte. 44 remained open to traffic as workers stabilized soil over approximately 14 acres.*

To control erosion during construction, staff stabilized site components over approximately 14 acres, including waste stockpiles that needed to be "locked up" for the Winter 2008 season to protect lower wetlands. Workers applied bare soil, then 4 in. of blown straw. To complete the stabilization process, they used a Finn T330 machine to administer 20 full loads of a blend of 100% wood fiber mix and 80 lb of tackifier.
