# Danger averted

Univ. of Mo. researchers evaluate mobile work-zone alarm systems in the field

By Henry Brown, MSCE, P.E.;  
Carlos Sun, Ph.D., P.E., J.D.;  
and Timothy Cope  
Contributing Authors

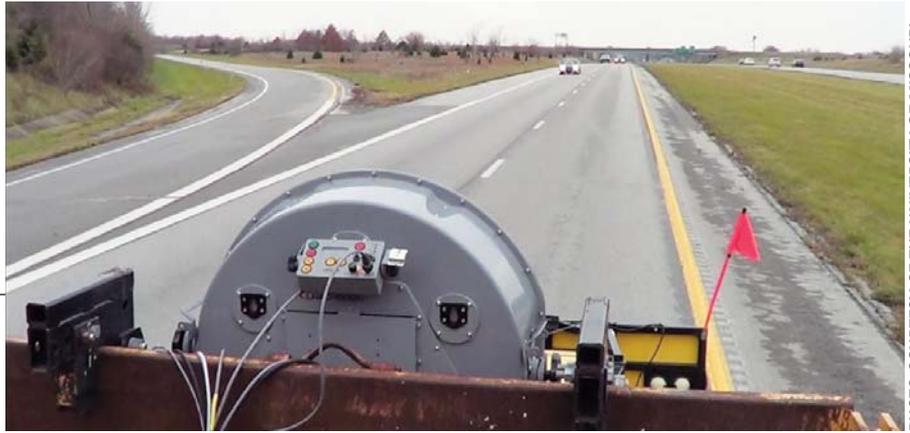
Field of view looking back from video camera mounted on TMA with DAS.

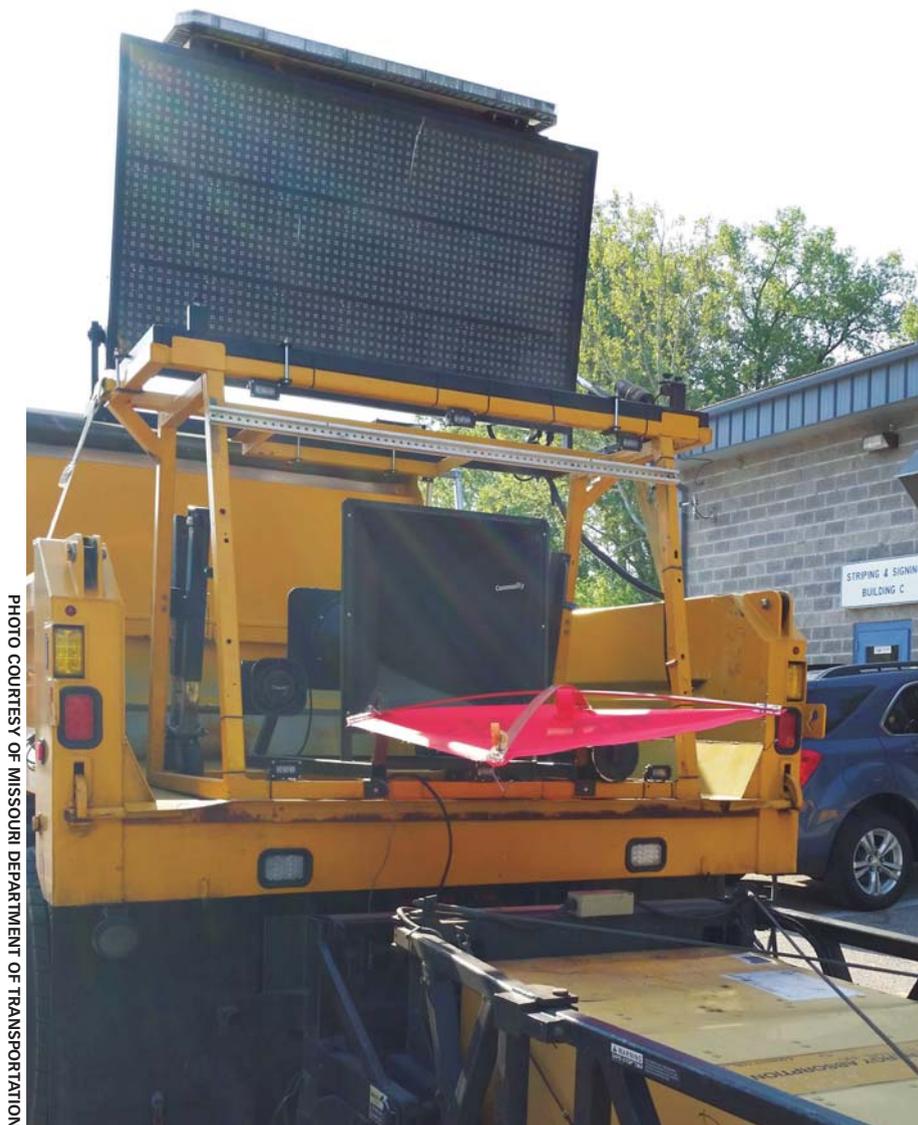
A speaker for an alarm device mounted on a VMA.
