# All's Well That Ends Well

Pennsylvania home receives water quality & energy efficiency overhaul

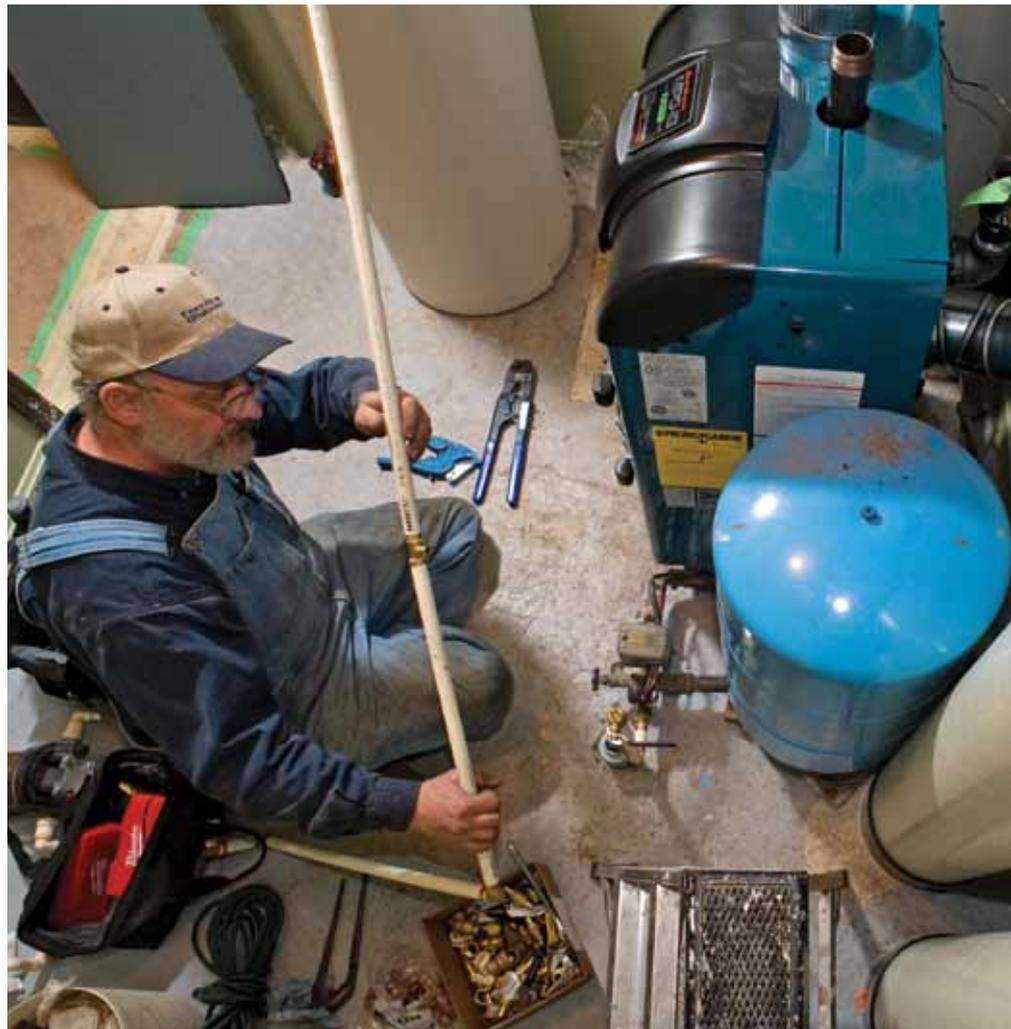
A technician prepares to install the new equipment in the Slusser home.

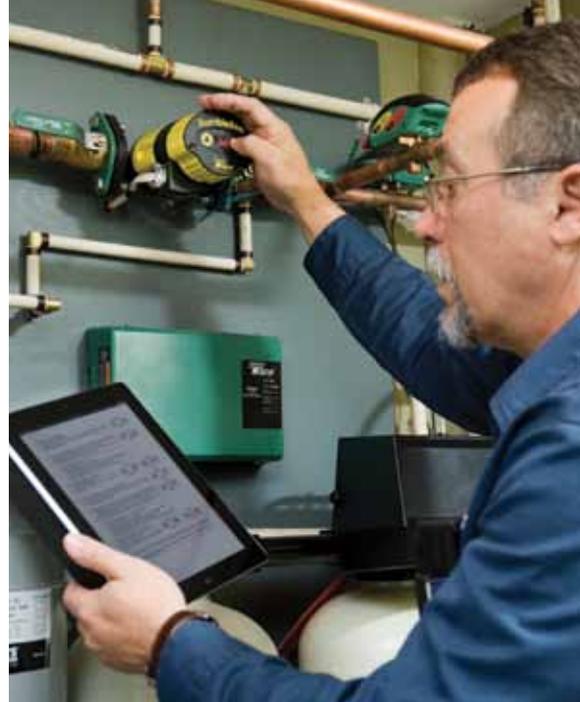
Yates uses a tablet to enter the correct operating parameters into the new circulator.

Yates built his parts list carefully. An energy-efficient Taco ECM circulator was set as the hydronic system's main pump. The circulator provides ideal flow to the upstairs and downstairs zones of the house. At each loop, the system uses a 1-W Taco Zone Sentry zone valve.

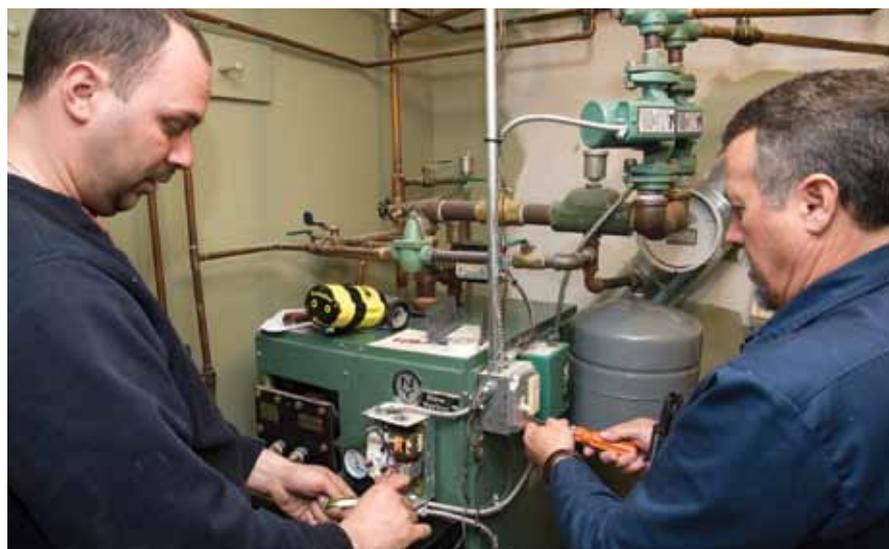
Yates and technician Larry Lawrence disassemble the original oil-fired boiler.

heating needs. Sure enough, the coil was badly calcified and barely warmed the water.

"Using Taco's FloPro Designer software, I learned quickly that the old boiler was rated for an output nearly three times what the house needed," Yates said. The boiler was oversized and short-cycling, to say nothing of the oil it burned while attempting to heat the DHW. So, in early 2014, with oil prices hiking feverishly, it was time to downsize.

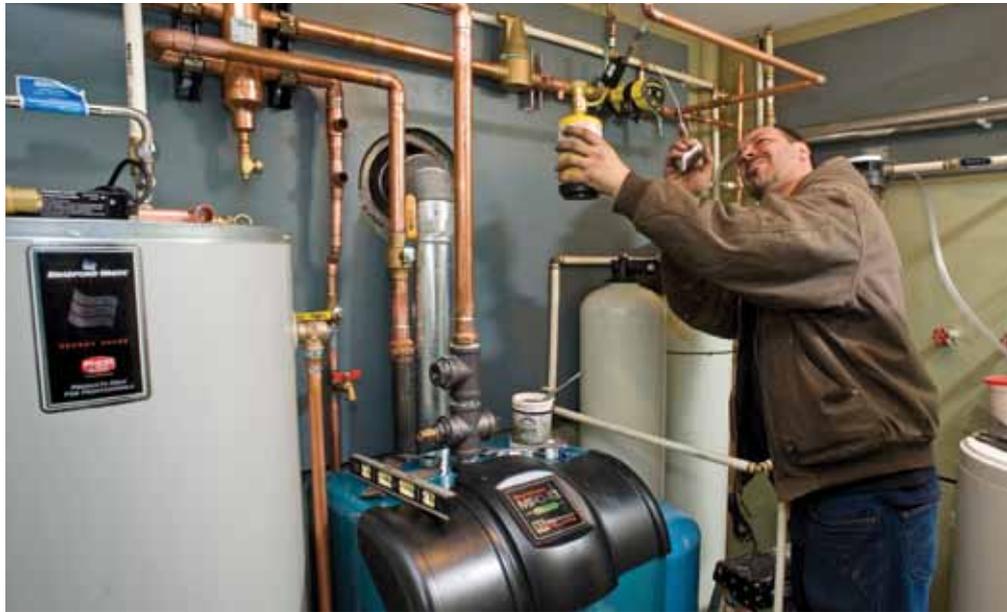
The water treatment and softening system ensure water is safe to drink and appliances are protected.

The Slussers did not want to expose the new water fixtures to scale, even if it meant using a dual-tank softening system. A twin-tank Watts water treatment system was installed; while one tank is recharging, the other conditions incoming water.

A new 12-gal-per-minute Watts whole-house UV disinfection system accompanies a media filter on the wall above the water softener. If power is lost to the house, a solenoid valve closes; no contaminated water slips by the UV light to re-seed freshly sterilized domestic water.
