isolating inflow & infiltration

Sanitary district utilizes flow monitoring data to eliminate backup events

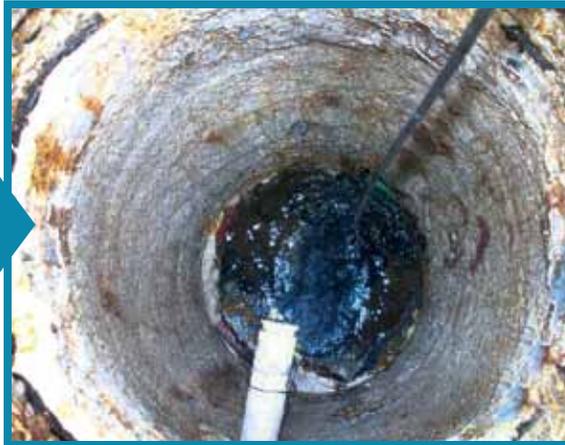
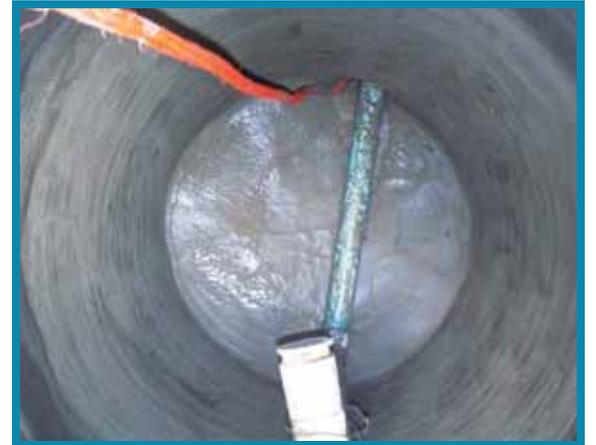
Left: Damaged manhole before rehabilitation work
Right: Manhole after repair

DCSD subsequently received a \$200,000 statewide grant to assist with infrastructure rehabilitation. "We made the decision early on in the process to focus our attention on the manholes first," Arbuckle said. "We identified leaks in manhole covers and vandalism as a major source of our inflow problem."

DCSD replaced the lids on 500 manholes with sealed and locked lids. Manholes with severe cracks and holes were lined with cement. DCSD sent notification letters to homeowners when root intrusion or cracks were found in lateral lines to prevent backups from occurring. Homeowners were pleased with DCSD for its proactive efforts.
